NUMI targets

Down until ~ Nov. 1 to replace target

A. E. M.
October 4, 2010
Jim Hylen/FNAL
Page 1

NT-04 failure

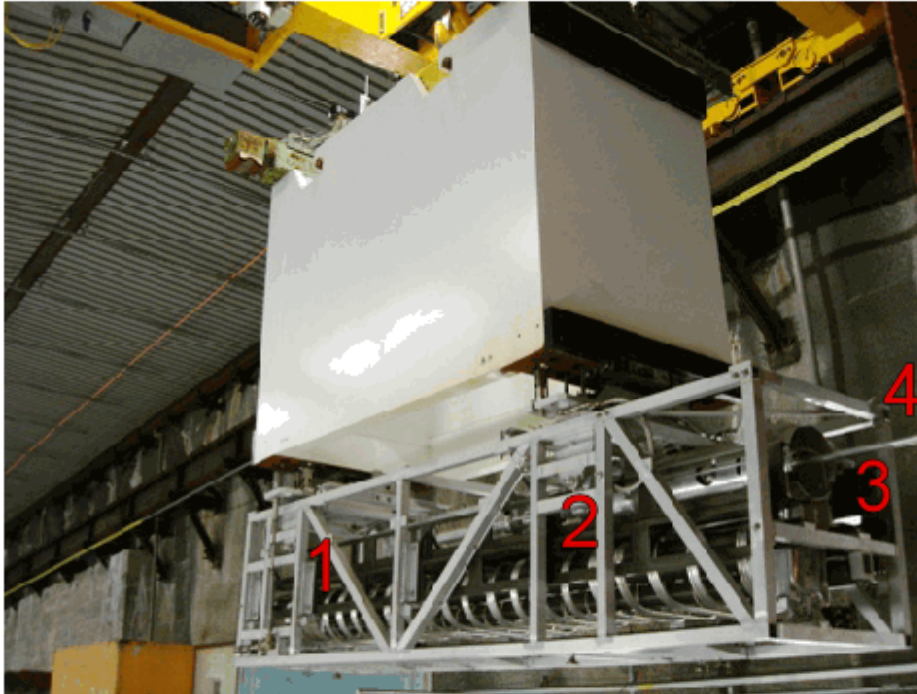
NUMI Target Beam Right

Tip would give weekly dose limit in 4 seconds

1	4000
2	10000
3*	40000
4	15000

* note: point #3 was taken on contact with the target tip, with the target in the LE 100 position

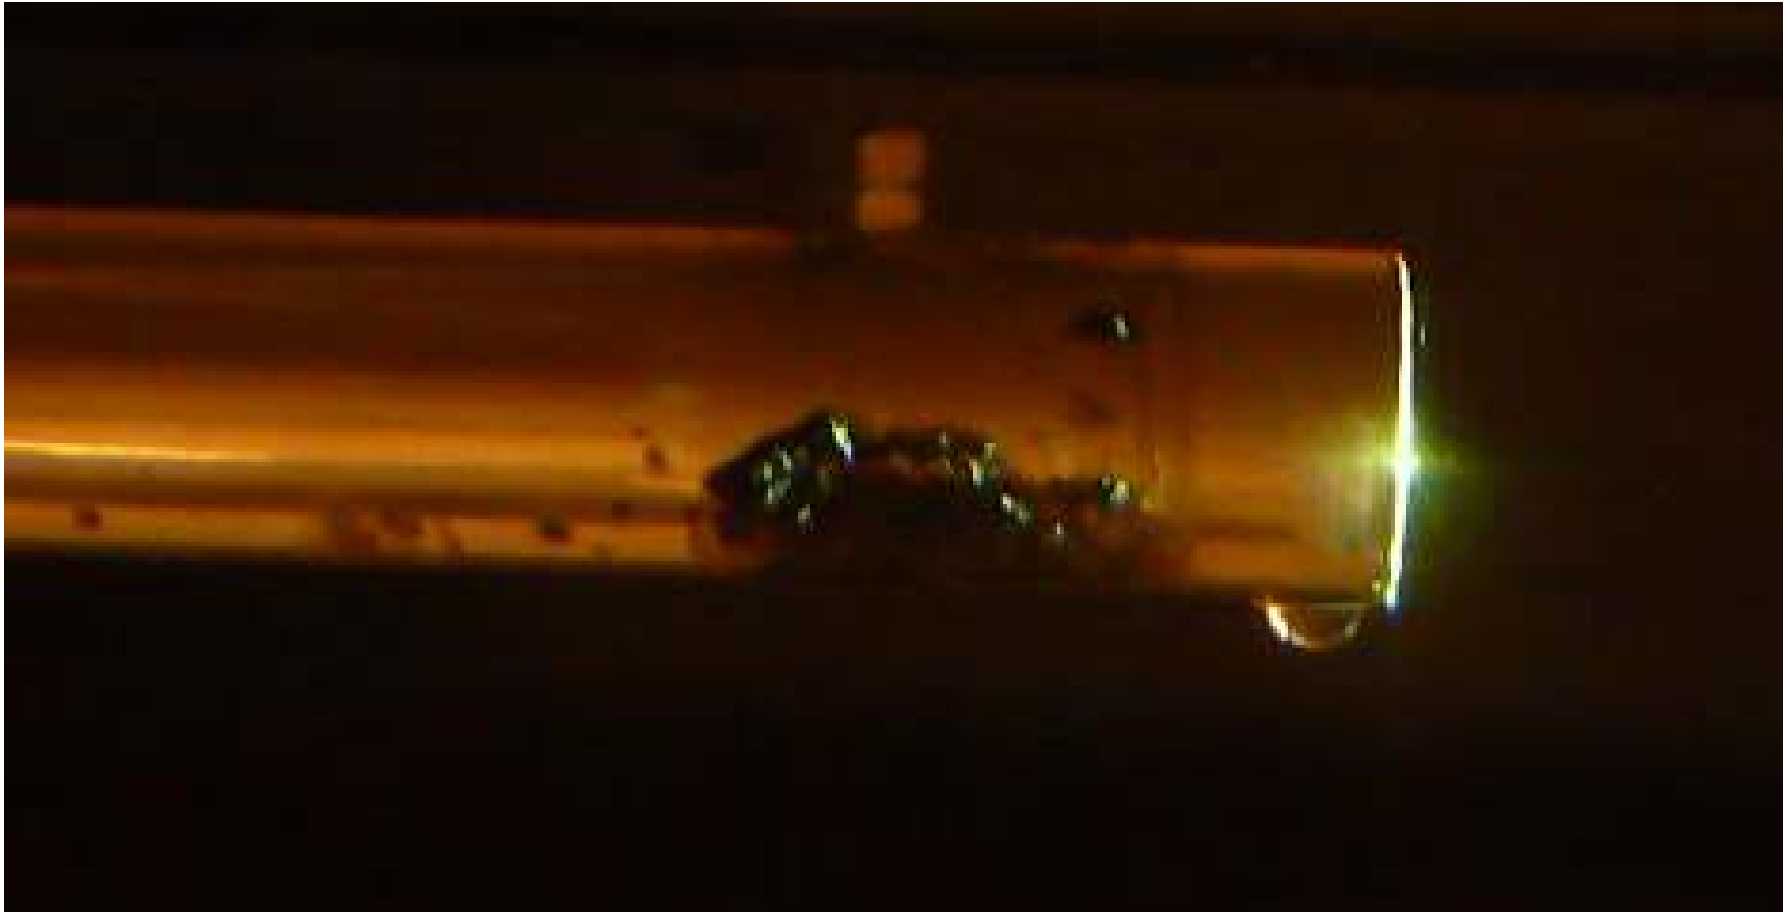
NT-04 target tip

See water drip, corrosion looks like left by water.

Other tests: See tiny hole in top during smoke-test.

See evidence of tiny water holes on Be window.

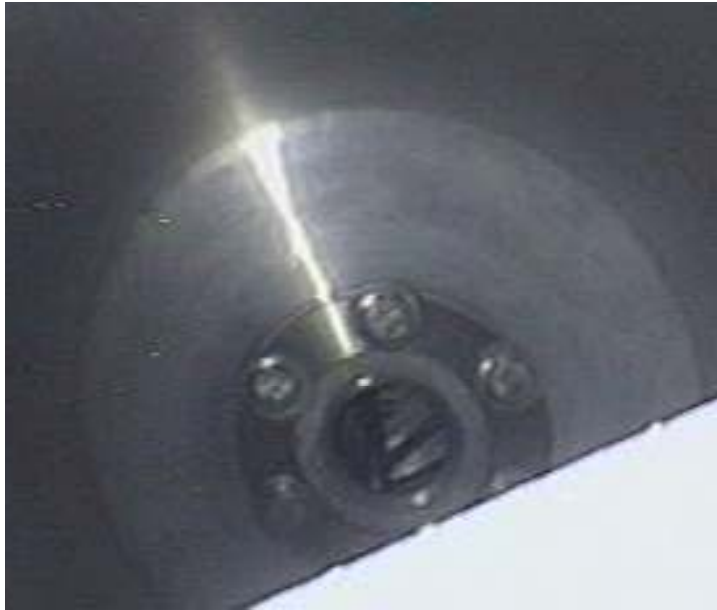
What upstream "window" looks like:

Most of Beryllium is on floor
of target pile , although

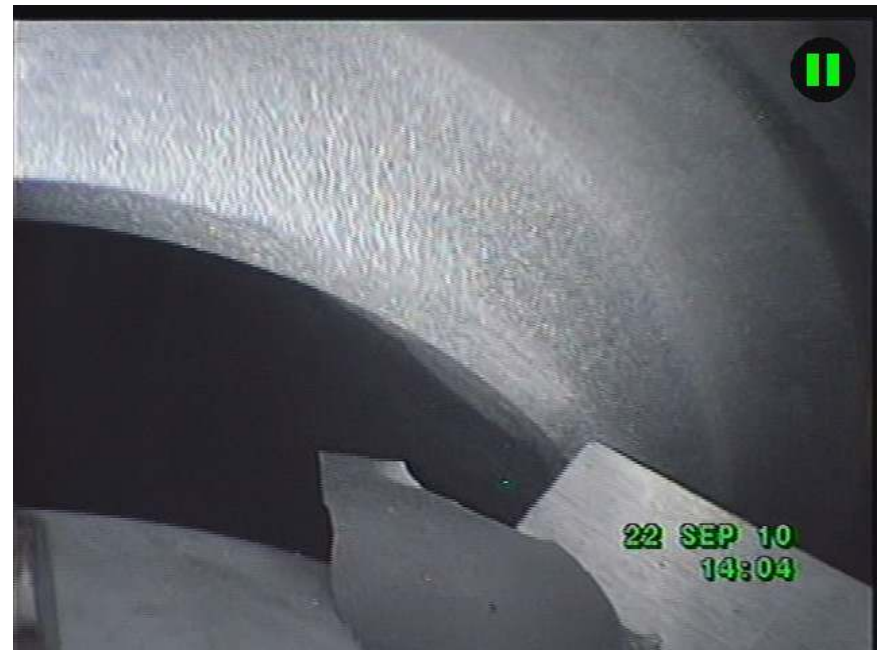
Beryllium window shard
resting on upstream baffle:

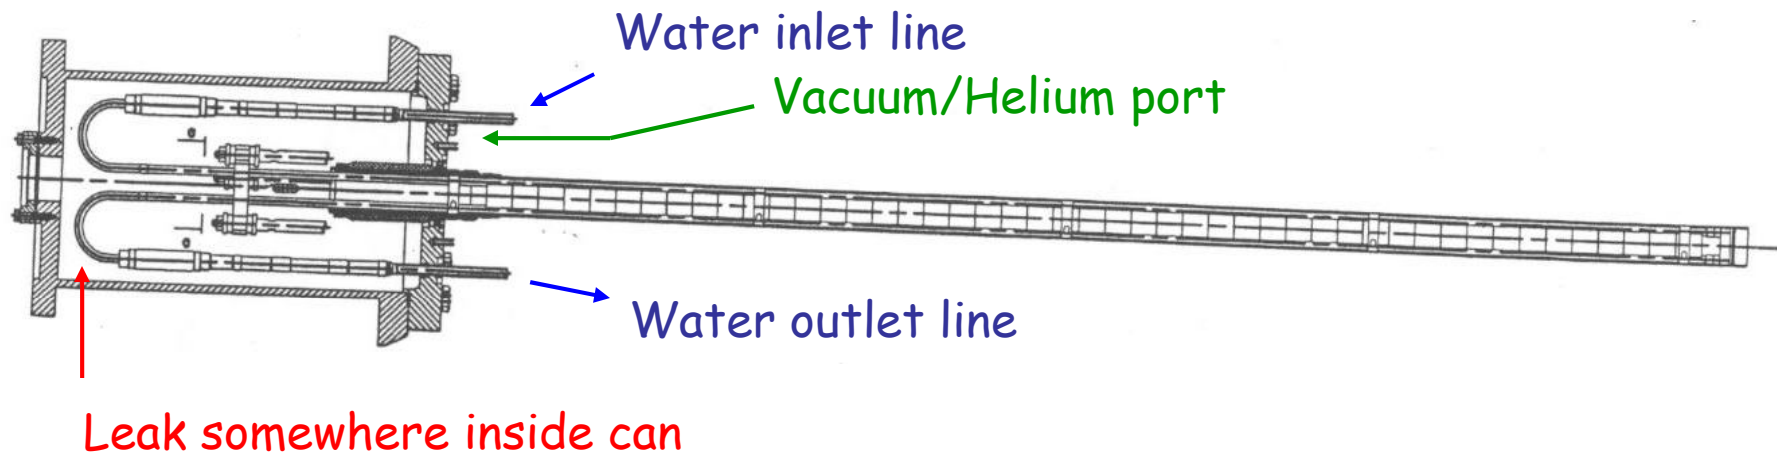
Target NT-01 water leak

On March 23, 2005 water leaked from cooling line into vacuum can, flooding target.

After draining target, we pressurized the can with 23 psig helium
(was planning to use helium for high power running anyway)

Helium bubbled through leak to water line, keeping water out of target.

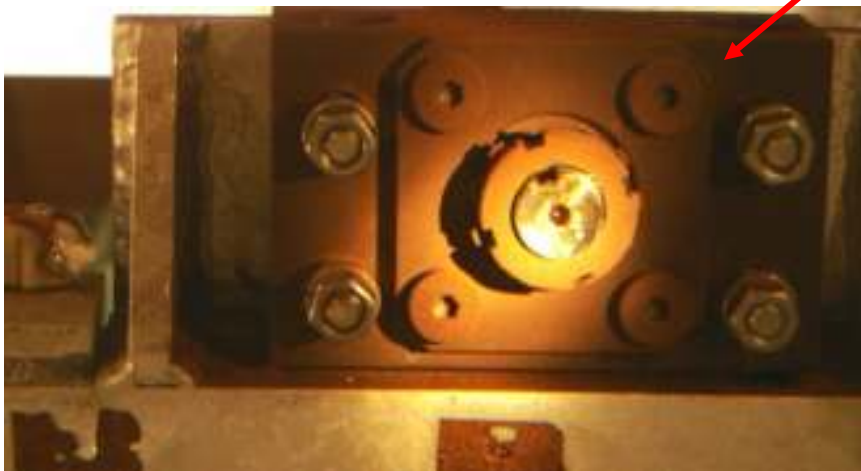
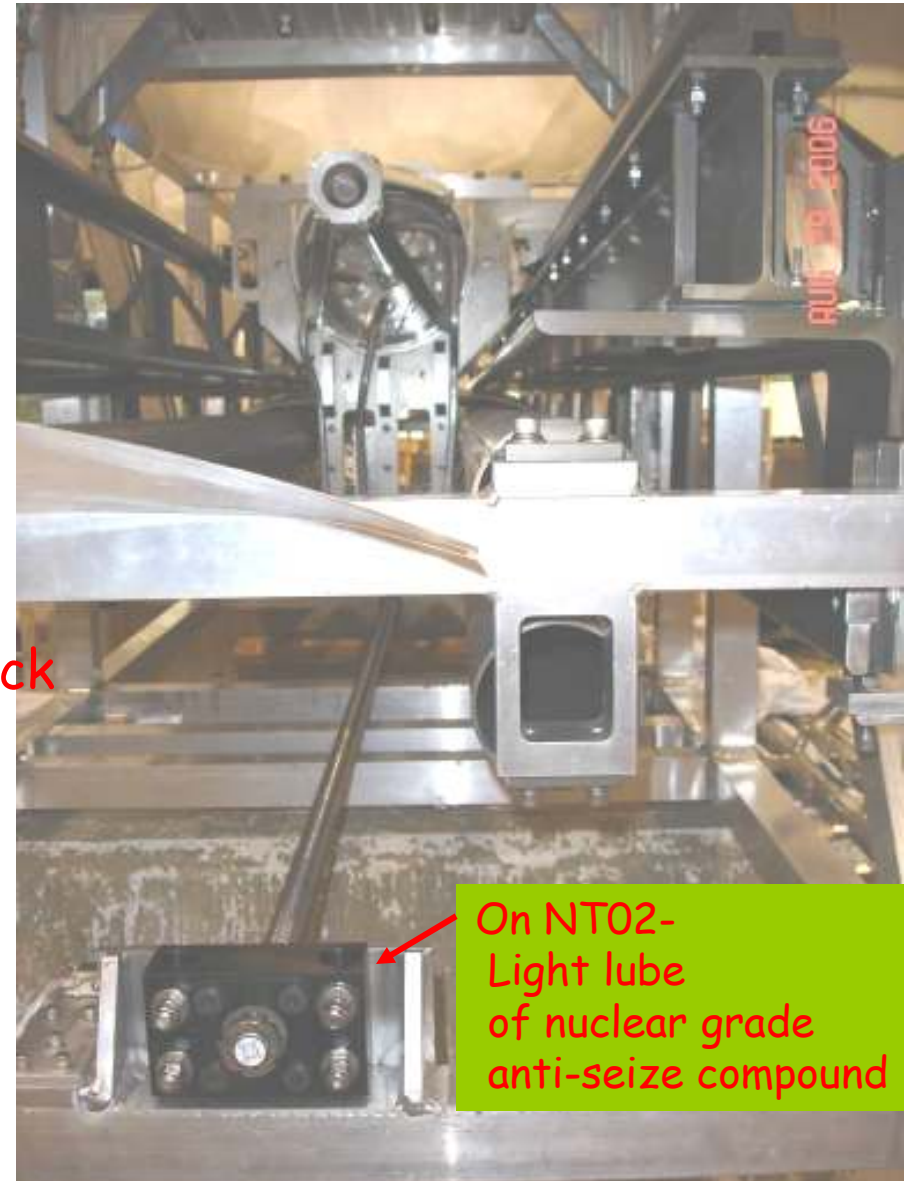
Old jammed pillow-block

After month-long test in High Energy position
drive shaft would not rotate to move target
into Low Energy position

NT03 onward, changed to graphite bushing
NT-03 drive moved smoothly at the end
of it's year lifetime.

On NT02-
Light lube
of nuclear grade
anti-seize compound

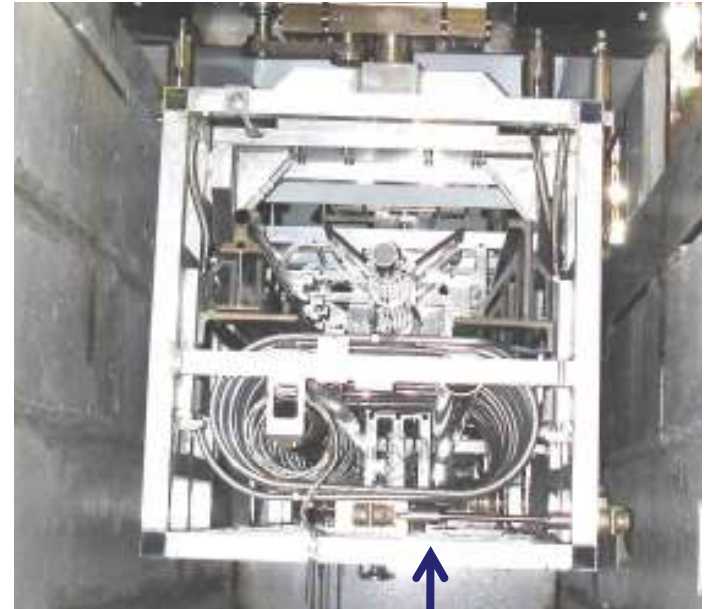
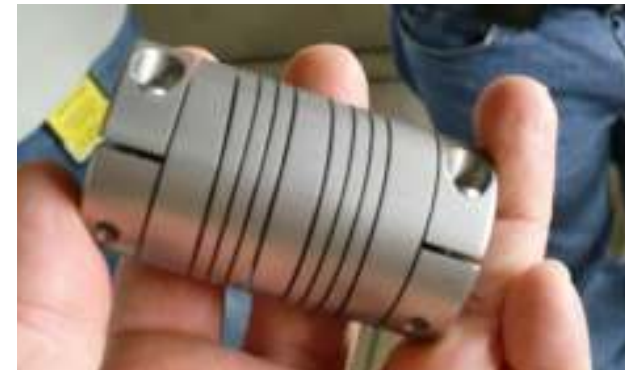
Target remote drive coupler failure (repaired)

Air + radiation = nitric acid

Nitric acid atmosphere

→ hydrogen embrittlement of high
strength steel

→ steel cracks

High strength steel bolts in couplers on
target

drive linkage failed, so could not move
target

Have changed to non-high-strength bolts.

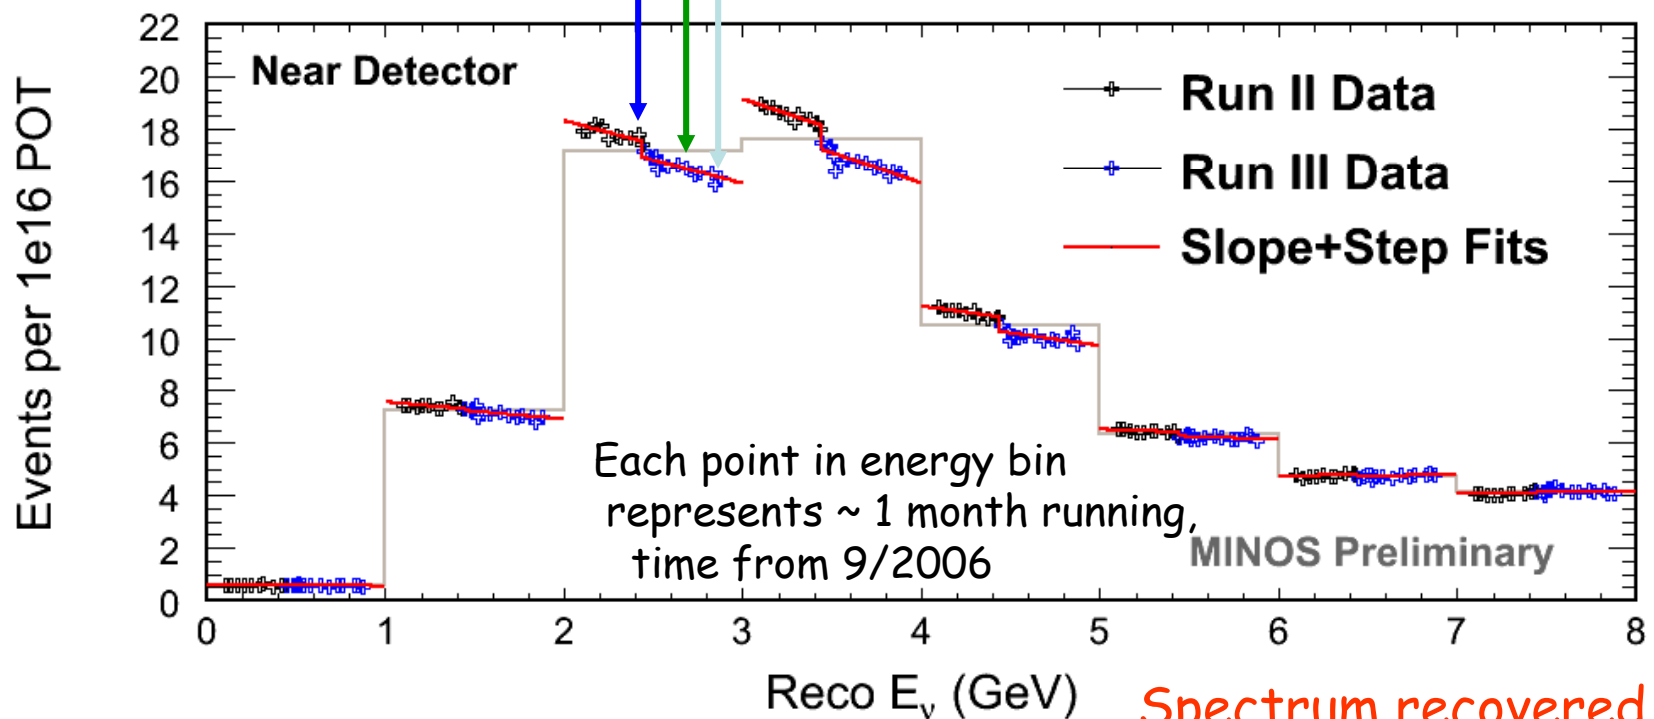
Gradual decrease in neutrino rate attributed to target radiation damage

Decrease as expected when decay pipe changed from vacuum to helium fill

No change when horn 1 was replaced

No change when horn 2 was replaced

Spectrum recovered when new target was inserted

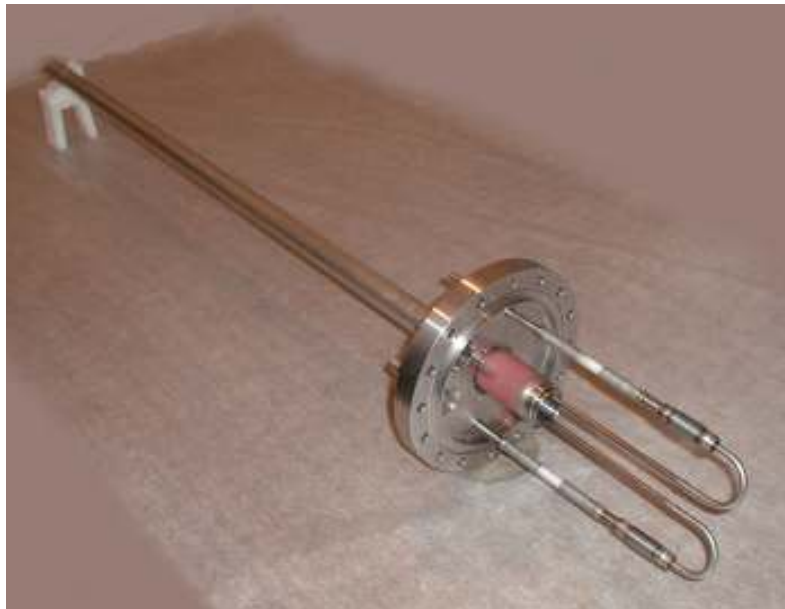
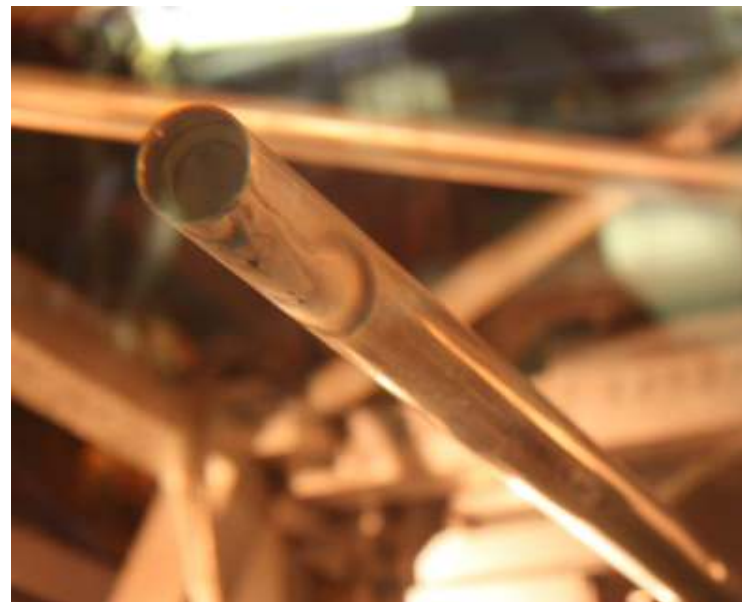
NT-03 failure

Helium leak developed, and target fin moved beam-left.

Exam showed leak at ceramic insulator at base of target - presumed cause is failure of braze joint or ceramic causing (X=4 mm, Y=8 mm) displacement of target tip

Exam also showed helium leak/damage at bottom of target tube

- presumed collateral damage from horn current with target resting on horn conductor (which limited the vertical displacement to 6 mm)

We re-adjusted target so parallel to beam again, and ran another two months.
